Manhole Inspection Summary

Manhole # S25I__009MH

Inspection ☐ Is Incomplete Rating: **4) Poor**

Location Address: **1031 Holton Ave**

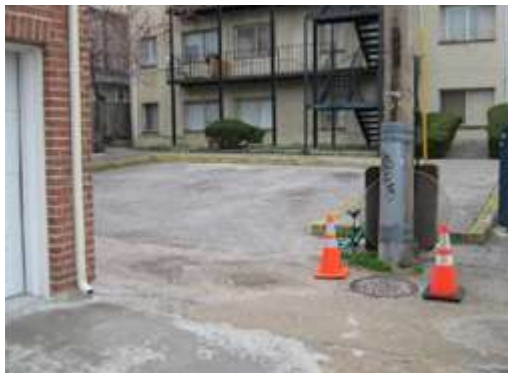
Location View

Holton Alley

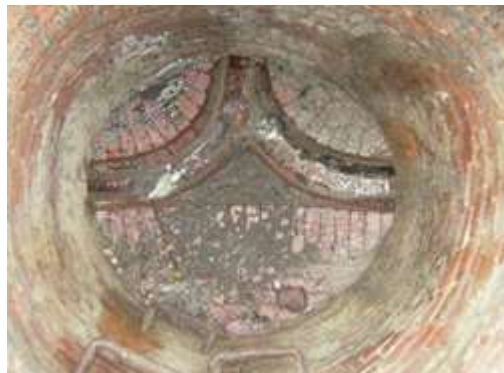
Top View

mh cover

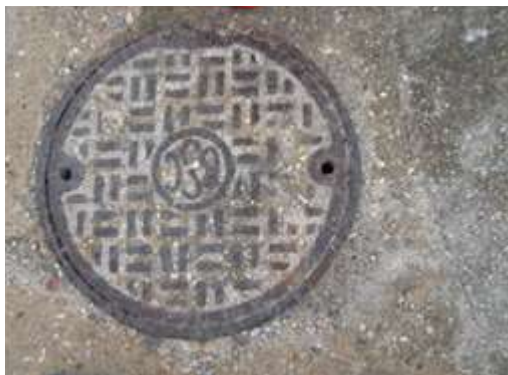
Defect 6

deteriorated chimney & infiltration, frame leaks

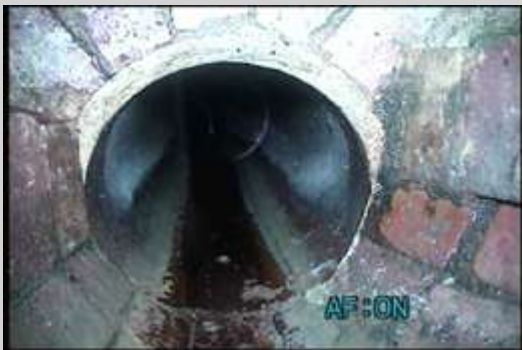
12 O'Clock Outflow

8 in. Circular Gravity Sewer
Pipe Out @ 12 O'Clock

Pipe Height: **8.4** (in.) Rod and Bar (Angled)
Pipe Material: **Clay** ☐ Pipe Lined
Invert Depth: **8.48** (ft.) Flow Characteristics: **Slow**
Deposits: ☒ None ☐ Mud ☐ Sludge ☐ Debris ☐ Grease
Silt Depth: **0** (in.) Deposits Extent:
Infiltration: **None** Pipe Seal Cond: **Sound**

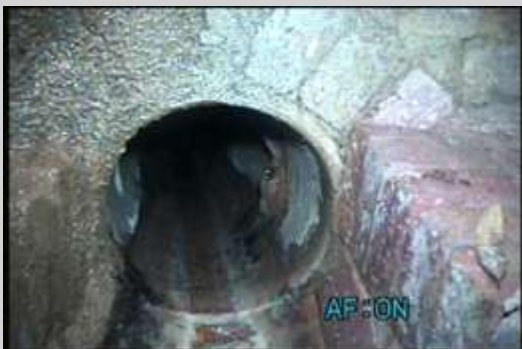
3 O'Clock Inflow

8 in. Circular Gravity Sewer
Pipe In @ 3 O'Clock

Pipe Height: **8.4** (in.) Rod and Bar (Angled)
Pipe Material: **Clay** ☐ Pipe Lined
Invert Depth: **8.04** (ft.) Flow Characteristics: **Slow**
Deposits: ☒ None ☐ Mud ☐ Sludge ☐ Debris ☐ Grease
Silt Depth: **0** (in.) Deposits Extent:
Infiltration: **None** Pipe Seal Cond: **Sound**

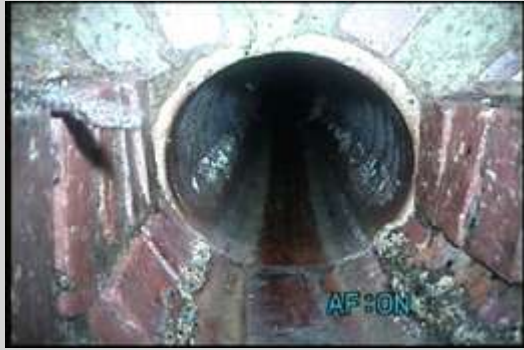
9 O'Clock Inflow

8 in. Circular Gravity Sewer

Pipe In @ 9 O'Clock

Pipe Height: **8.4** (in.) Rod and Bar (Angled)

Infiltration: **None** Pipe Seal Cond: **Sound**
